# Manhole Inspection Summary

Manhole # S41QQ\_018MH

Insp Date: **4/4/07 8:22 AM**

**Location** Address: **900 25TH ST**

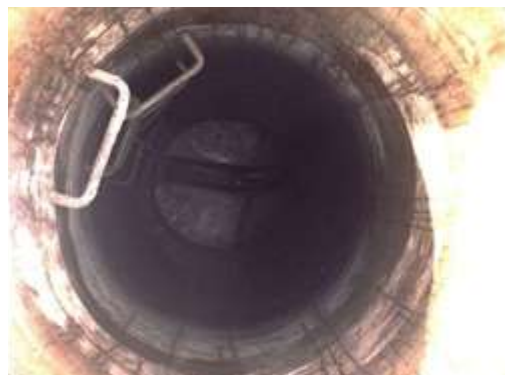
Top View

Frame leaks. Corbel and Barrel infiltration.

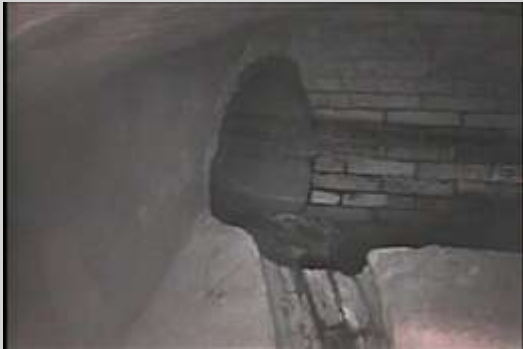
### 24 in. Circular Gravity Sewer Pipe Out @ 12 O'Clock

Infiltration: **Evidence** Pipe Seal Cond: **Unknown**
